Division of Water Rights

November 2, 2009

RE: SEAA No. 1290, Measuring flumes, Logan Island No. 1 and 6&7

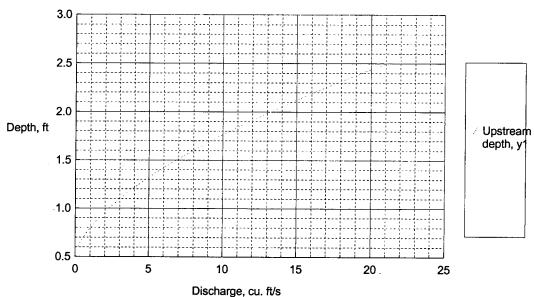
## Logan Island 6&7 - Revision 22

Logan Island No. 6&7 2' Ramp Flume Rating Table -- Not yet verified. Geometry: 2 ft approach, 3.5 ft ramp, 1.5 ft crest at 0.5 ft height.
